TECHNICAL ASPECTS OF QUALITY ASSURANCE IN MAMMOGRAPHY: PRELIMINARY RESULTS FROM SERBIA

Monika M. ŽIVKOVIĆ¹, Tomislav J. STANTIĆ², and Olivera F. CIRAJ-BJELAC^{3*}

Short paper

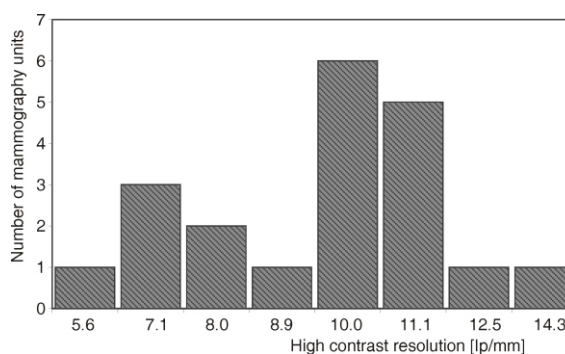
An objective assessment of image quality was performed using a TOR MAS test object. The results of our image quality scoring are presented in figs. 1 and 2. The minimal detectable contrast for 5.6 mm circular details, simulating tumour masses of 0.5 mm and 0.25 mm details, simulating microcalcifications, is presented in figs. 3 and 4, respectively. Results obtained demonstrate a wide range of image quality indicators: high contrast resolution ranges from 5.6 to 14.3 lp/mm, while the low contrast resolution was in the range of 1.8-5.0 lp/mm. With respect to the minimal acceptable level of high contrast resolution, this parameter, related to image sharpness, was suboptimal in 90% of the surveyed facilities. Similar findings pertain to all cases of low contrast and low detectability of microcalcifications, as presented in figs. 3 and 4. In a significant number of centres (40-90%), threshold contrast detectability was lower than the minimal re-

Figure 1. Results of high contrast resolution measurements in 20 mammographic units

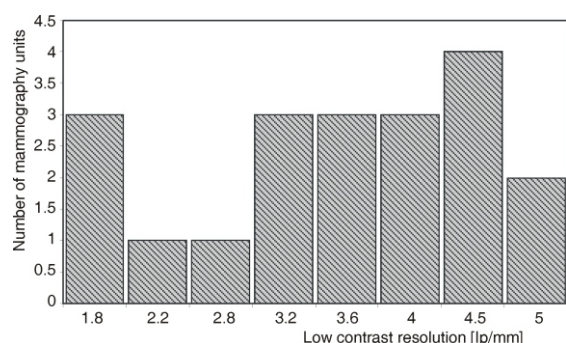
Figure 2. Results of low contrast resolution measurements in 20 mammographic units

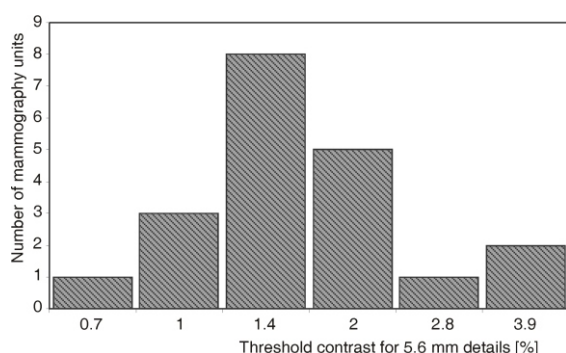
Figure 3. Distribution of measured values for minimal detectable contrast of 5.6 mm diameter details in 20 mammographic units

quired (1.2, 5, and 8% for details of 6 mm, 0.5 mm, and 0.25 mm diameter, respectively).

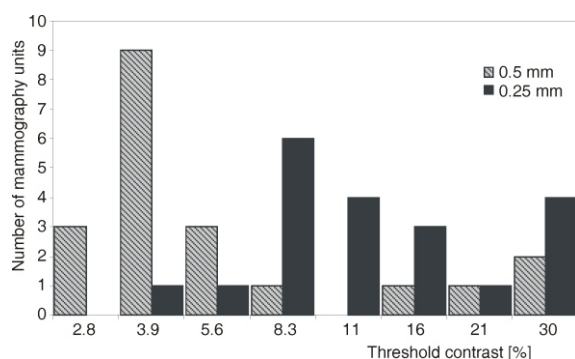
Figure 4. Distribution of measured values for the threshold detectable contrast of 0.5 mm and 0.25 mm diameter details in 20 mammographic units
